## BMC 'A' Series engine roller rocker valve gear modifications – and potential problems!

An alternative title, in Hylton's own words, "The disaster of fitting roller rockers to an 'A' Series engine"!

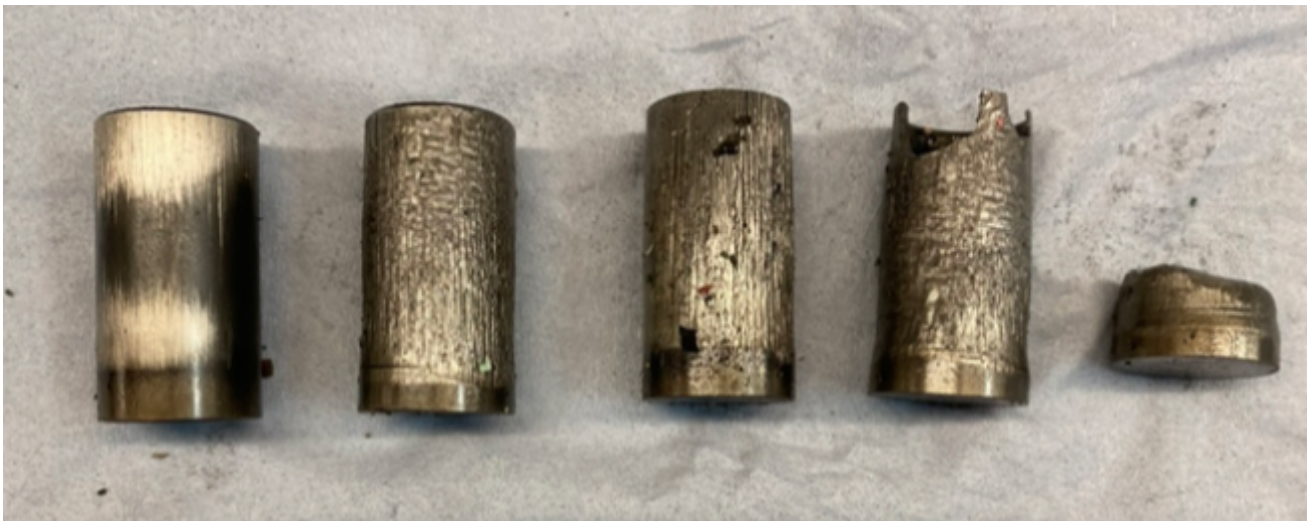
Ouch! Cam followers showing varying degrees of damage, as explained in the text by Hylton Reid.

Unfortunately, in my case, there was an unidentified high spot in the head casting which was rubbing on number 1 pushrod. This caused metal filings to fall down into number 1 tappet, and also into numbers 2, 3 and 4.

The heading picture shows the front 4 tappets, as removed from my engine. From left to right, the first one is from No. 4 and can be seen to be in reasonable condition, whereas the second is severely scored, the third is even more severely scored and has failed at the top.

The last one has virtually disappeared. This was the one that fell into the block, jamming the camshaft lobe and shearing off the camshaft drive. This stopped the engine!

Obviously, the bores in the block would also be severely scored, so just fitting new tappets would be a waste of time. The answer would be to find a replacement block. These are now becoming very hard to find for the 10CC (1098cc) engine, although 1275cc blocks can be located.

The solution was offered to me by Keith Calver of Calver ST in Malton, North Yorkshire - 'A' Series specialists (<https://www.calverst.com/>). The block needs to be re-bored slightly oversize and larger tappets fitted. The ones he suggested came from a Hillman Hunter. The only firm in the UK who could undertake the machining of the block were Damico Engines of Norwich (engine performance specialists: <https://www.damico-engines.co.uk/>), because the tappet bores are not fully vertical but are angled at 2.5 degrees!

Now that this work has been completed I have checked the clearance around the pushrod holes in the cylinder head. That is when I found the casting irregularity. The solution was to drill out all of the pushrod holes to a slightly larger diameter. Every one of them was not a “clean” hole and needed to be tidied up.
