## Assault and Battery? – Grumpy Old Mechanic

Published: November 16, 2015

Author: Kim Henson

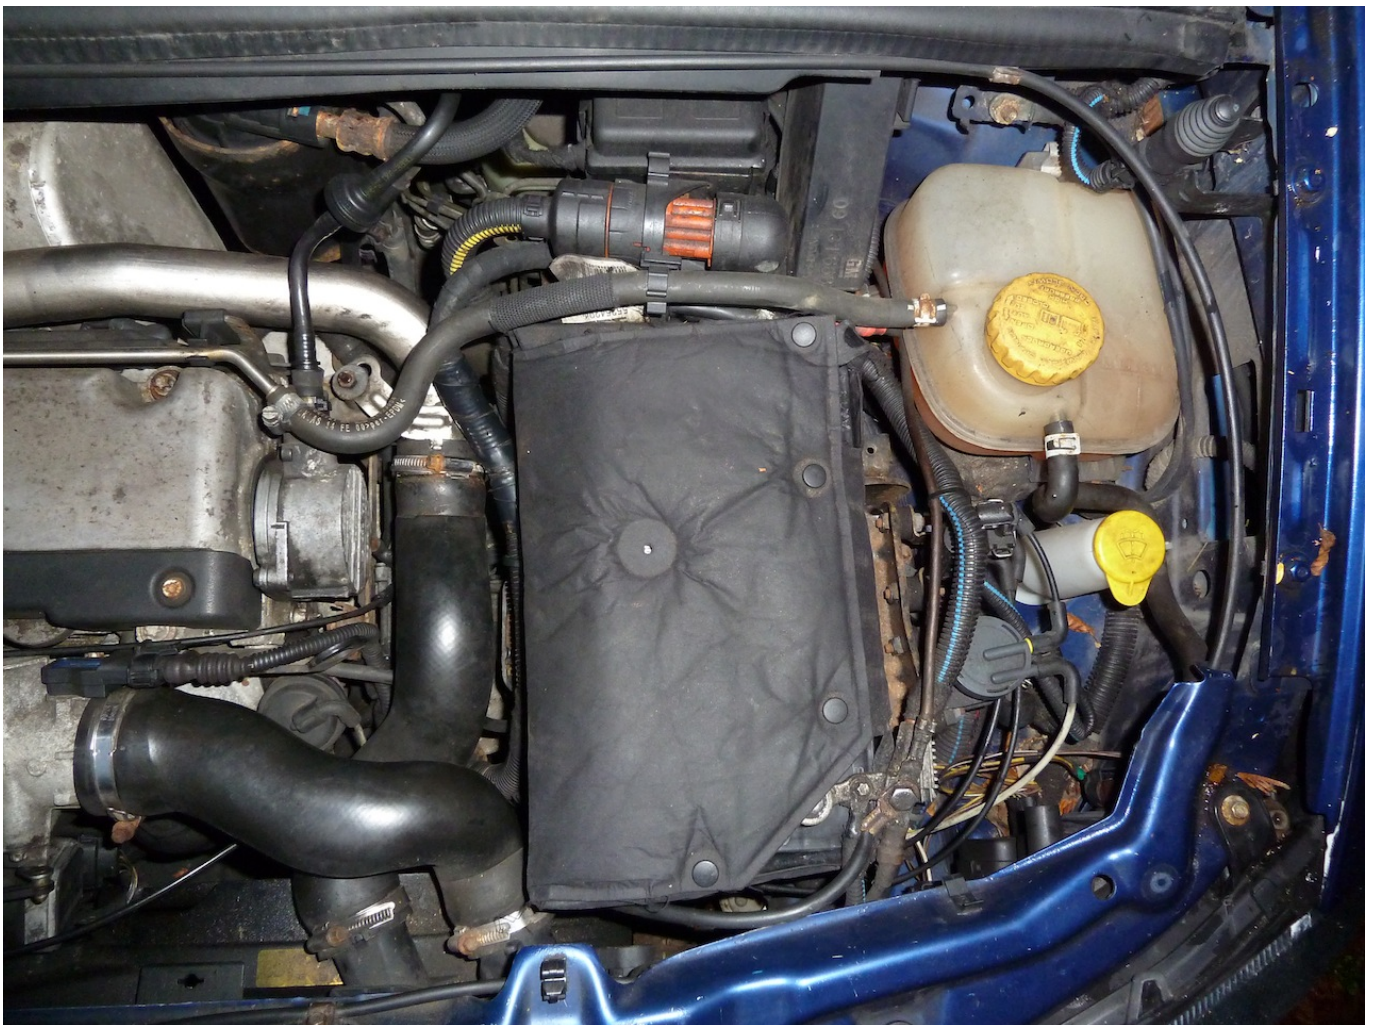
No way in? With many modern cars it's almost impossible to reach the securing clamp, when the time comes to fit a new battery.

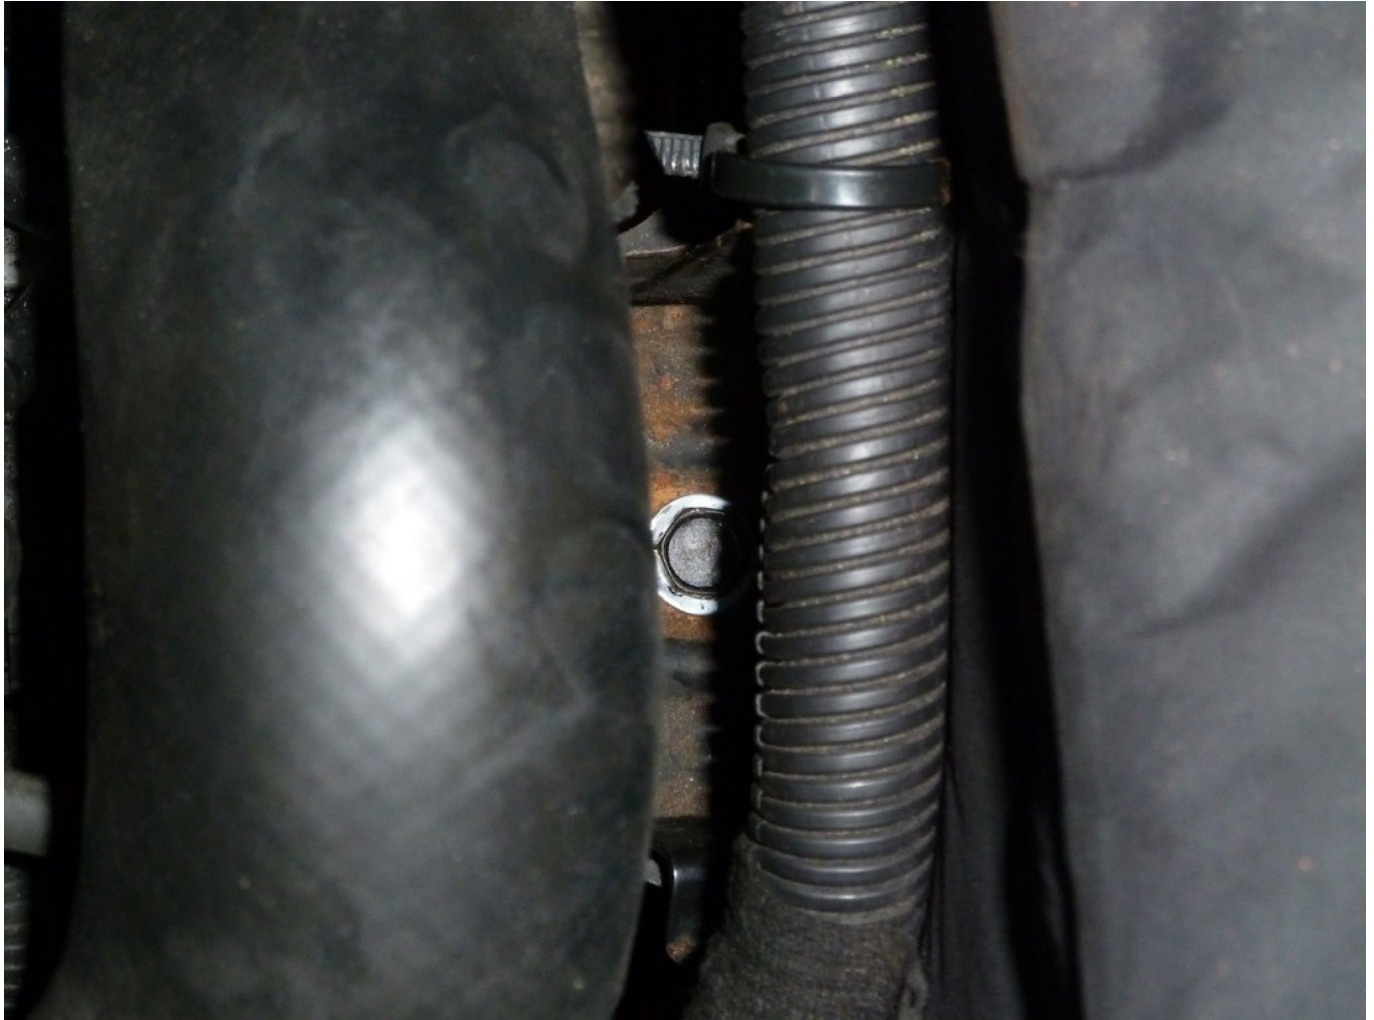
position (which would have been quite possible), it was buried in the depths of the engine compartment, amidst a maze of hoses and electrical wiring. Indeed it was almost impossible to see, let alone reach.

Spot the bolt for the clamp securing this battery... It's only just visible, let alone reachable, even after moving hoses, wiring, etc!

We found a new metric bolt, of the same thread dimensions but a little longer than the original (to make it a bit easier to install) and then attempted to fit this, together with new lock and plain washers.

Eventually we 'won' and the battery was installed, complete with its new bolt - but what a performance for a job that should have been quick and easy... How much easier it would have been if the clamp had been mounted in a slightly different position, where it could more easily have been reached.
